**North Slope of Alaska ARM Facilities
Monthly Status Update
Sandia National Labs**

November 2017

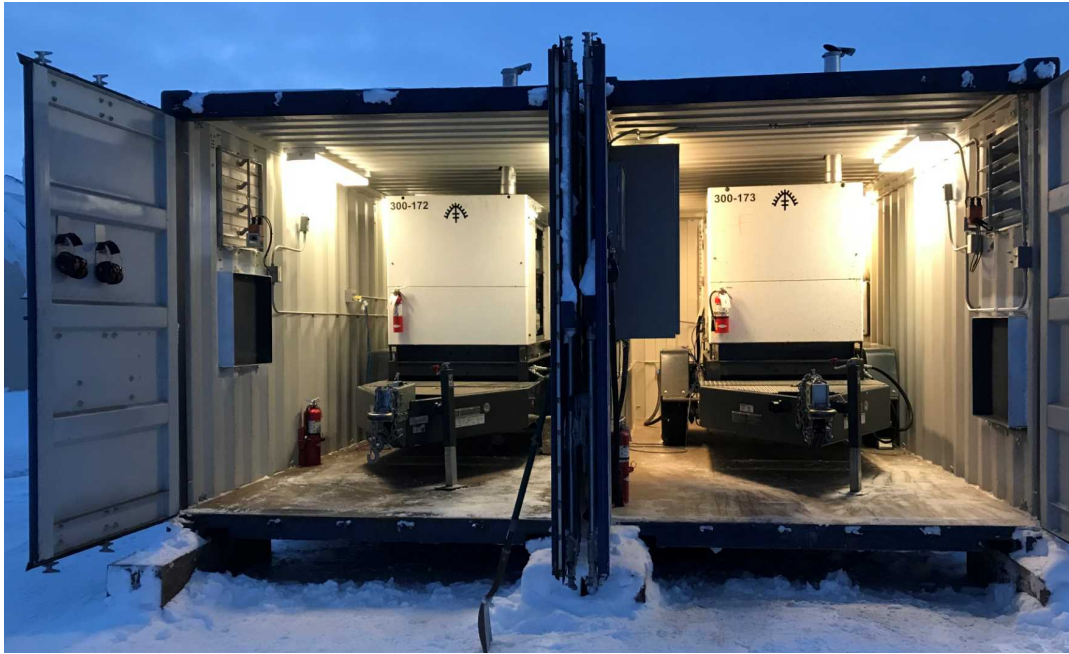
Two new shelters were added to house the site generators and protect them from the elements.

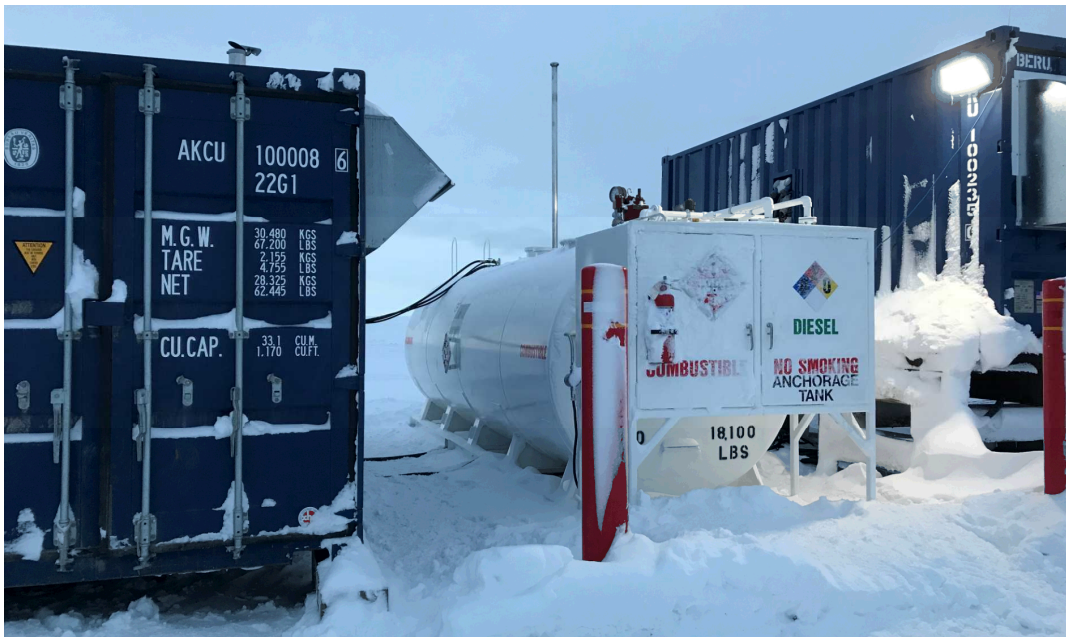
New 5000-gallon fuel tank.

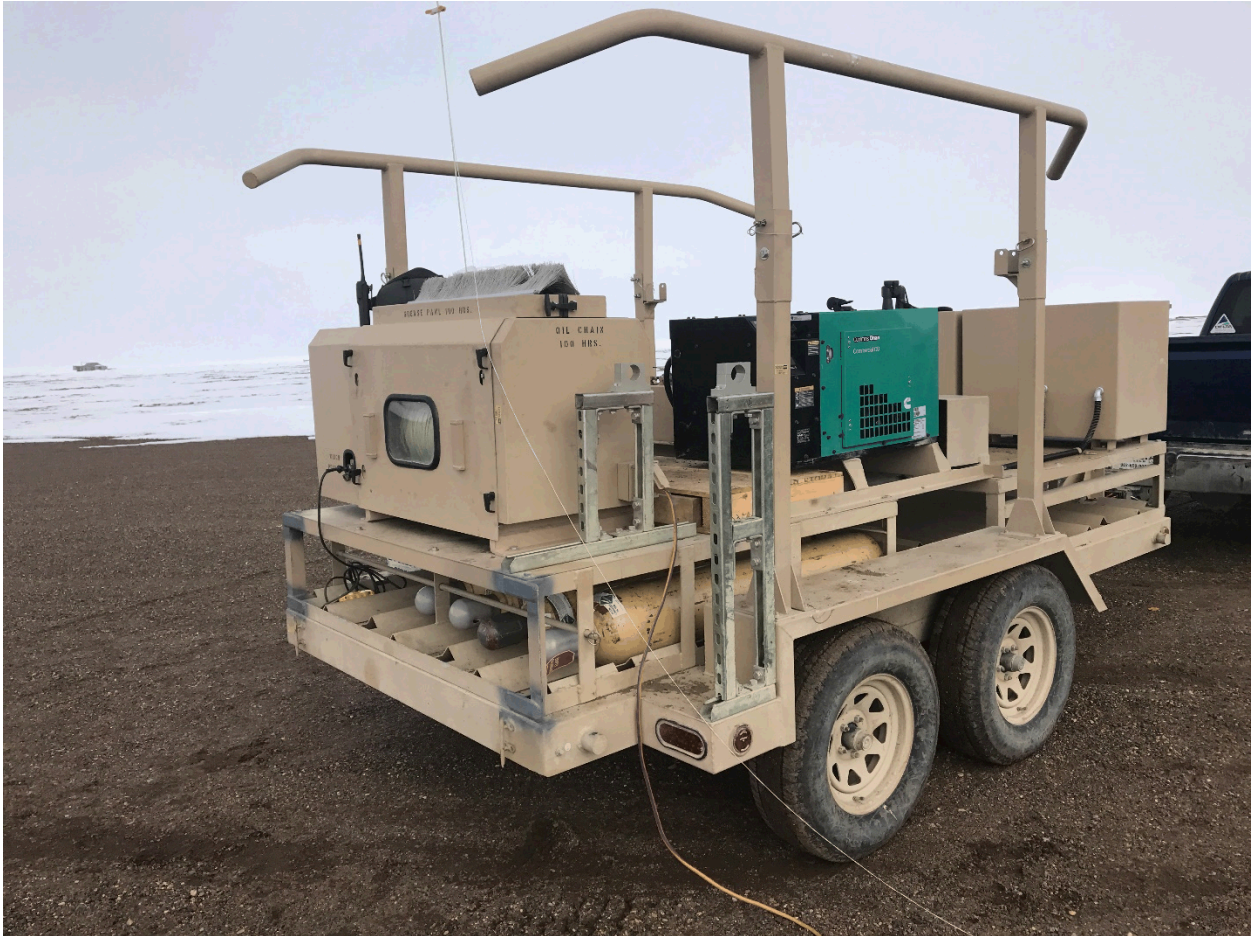
Figure 1: Winch trailer as it was initially configured upon arrival in Albuquerque

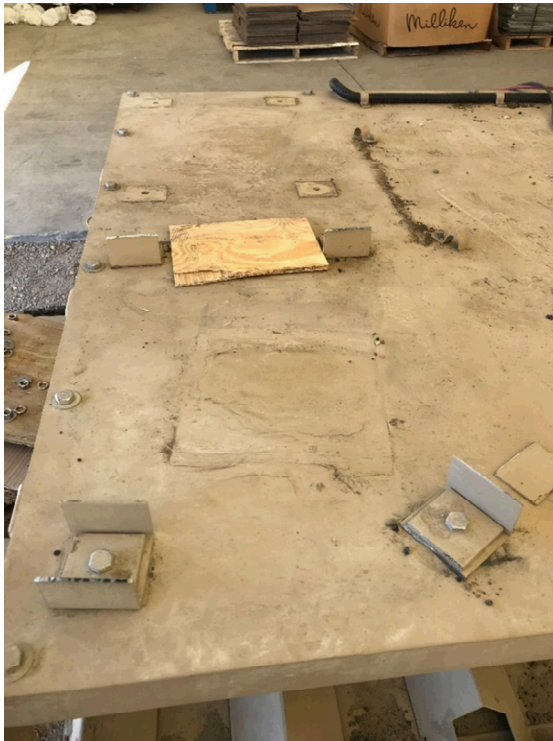
- a. First, we removed the two electronics boxes mounted of the front of the trailer. Upon removal, we found most of the support brackets for the boxes had cracked.

Figure 2: Cracked electronic box supports

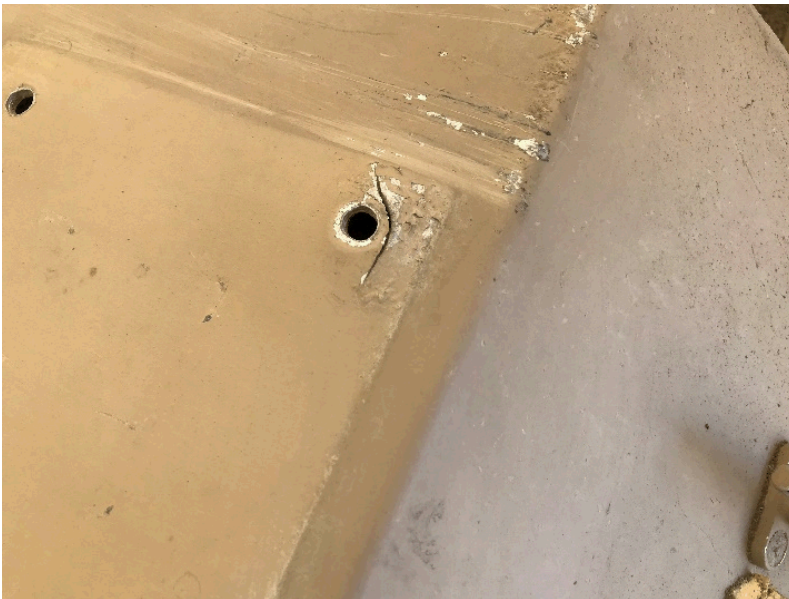
- b. The balloon support arms were removed next and then the generator. Upon removing the support arms, we found the arms to be flimsy and their mounting locations to be undesirable. A stress crack was found under one of the mounting locations proving the location was inadequate.

Figure 3: Stress crack under balloon arm mounting location

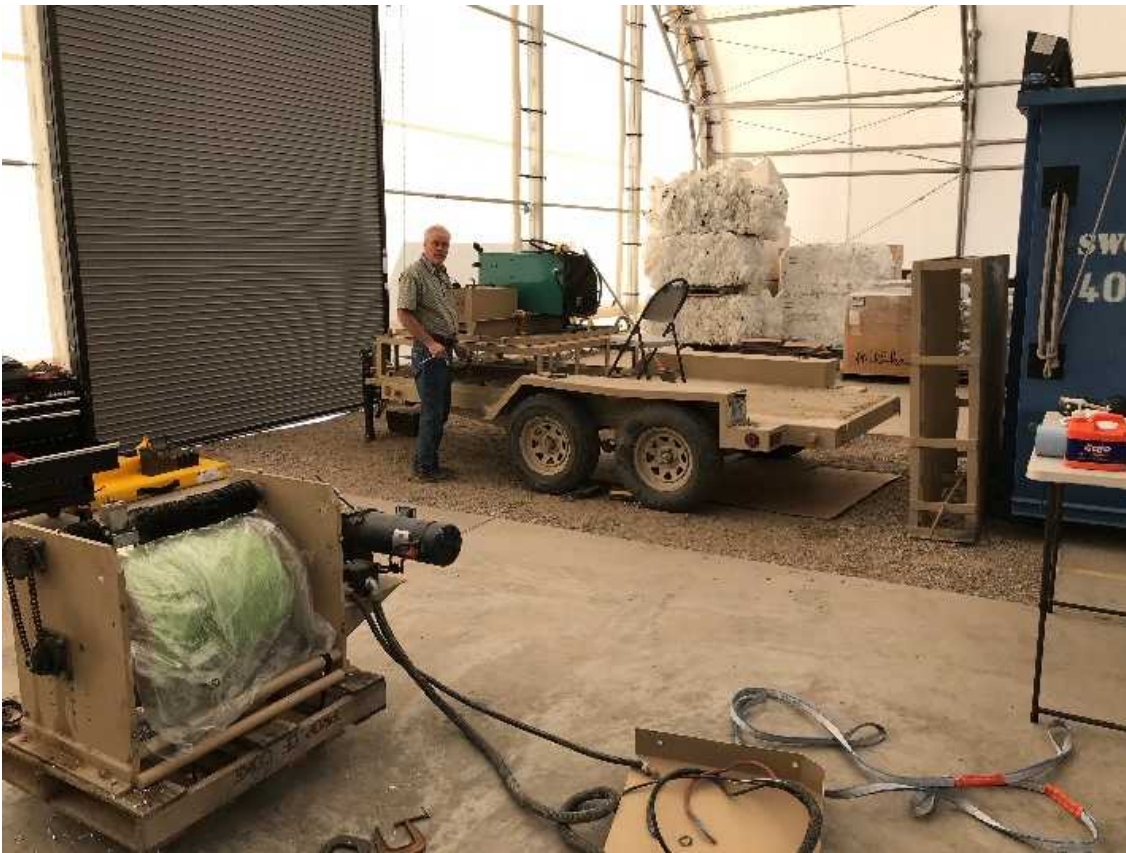
Figure 4: Trailer with generator in front and back helium bottle storage removed

- c. The generator was relocated to the front of the trailer and the winch and back helium bottle storage were removed.

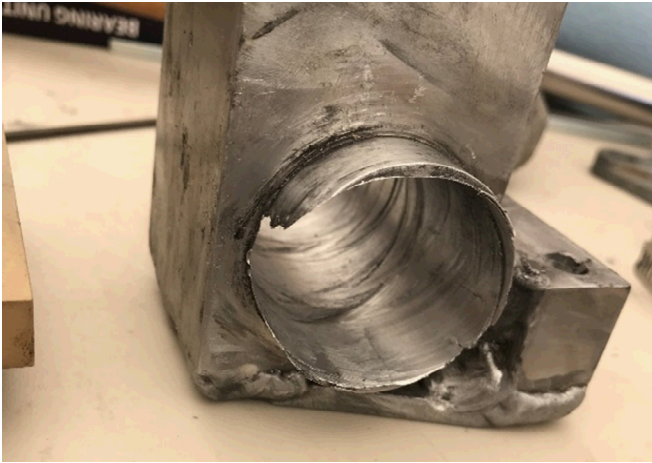
- d. We disassembled the old winch and found many issues. The level wind housing had been wearing against the shaft due to inadequate support from the roller mount. This caused extreme wear on the housing as well as aluminum shavings to be spread across the level wind shaft. All the grease and shavings were cleaned off the old winch as well as identifying parts that needed to be replaced. The support shaft was changed to utilize the winch drive to spin the shaft preventing binding in the linear bearing with the new level wind roller. This linear bearing will serve to prevent premature wear of the level wind housing during future operation. The gearing of the pawl motion was also improved so it will evenly lay the tether across the entirety of the drum which will save space and potentially allow a longer tether to be used.

Figure 5: Extreme wear of existing winch level wind housing

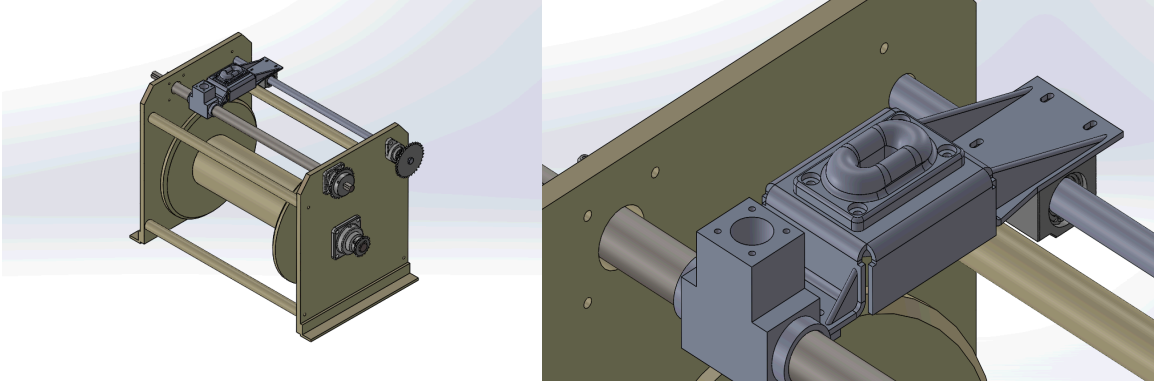
Figure 6: Model of new level wind design on winch

A 3D SolidWorks model of our winch was developed. Using the model, a new design for the level wind winch mechanism was created. From the model, a rough prototype of the design was created which will be tested with a tether under tension. The goal of the new level wind design is to prevent damage to the tether when the tether deviates over 60° from being parallel to the winch (cross wind to trailer) or a severe tether angle occurs in cases of low lift or high winds.
